(Annex 2-5)

5. The Marshlands in Ngoma

4. The individual data of the Marshlands in Ngoma

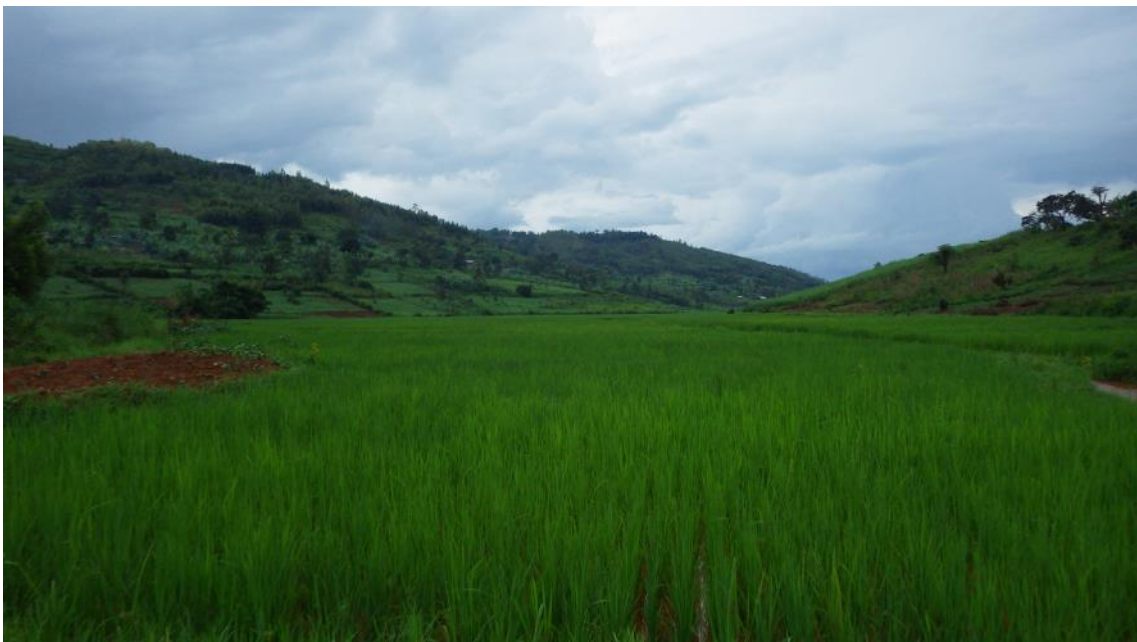
There is enough water, but sometimes flooded in the downstream areas of this marshland.

You can see the Weir. There is no Dam.

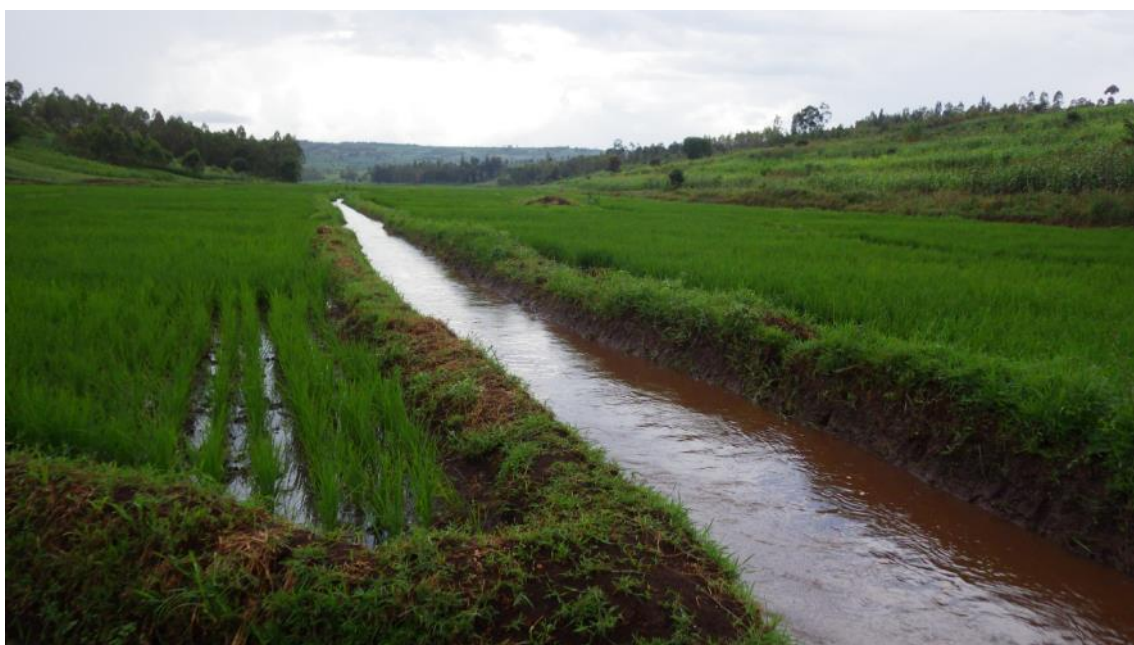
The maintenance of the canal is not good.

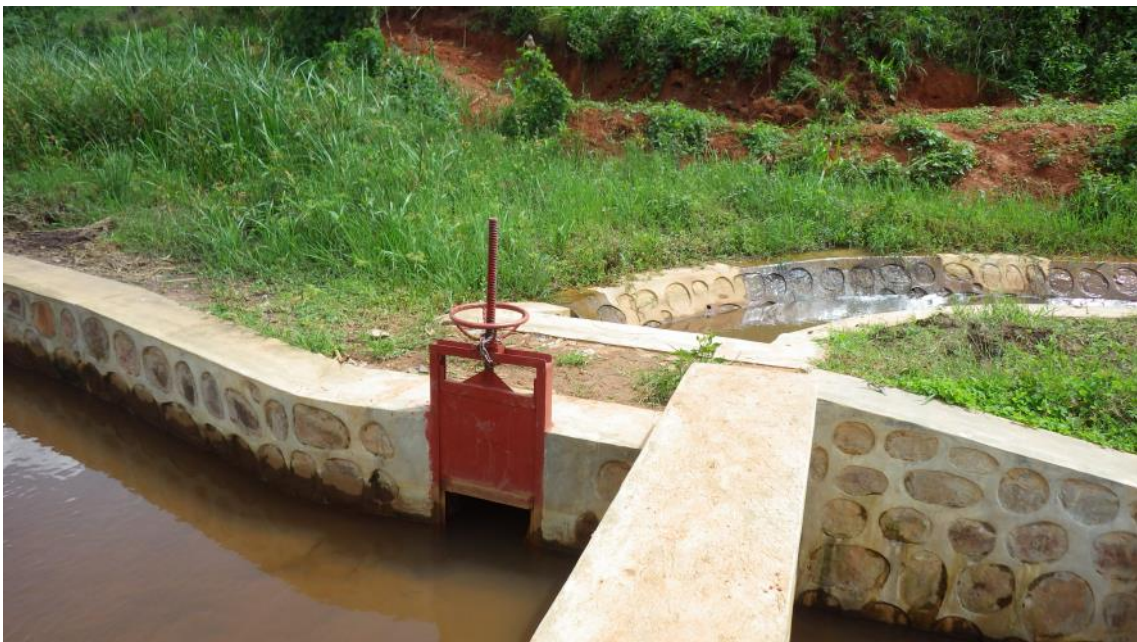
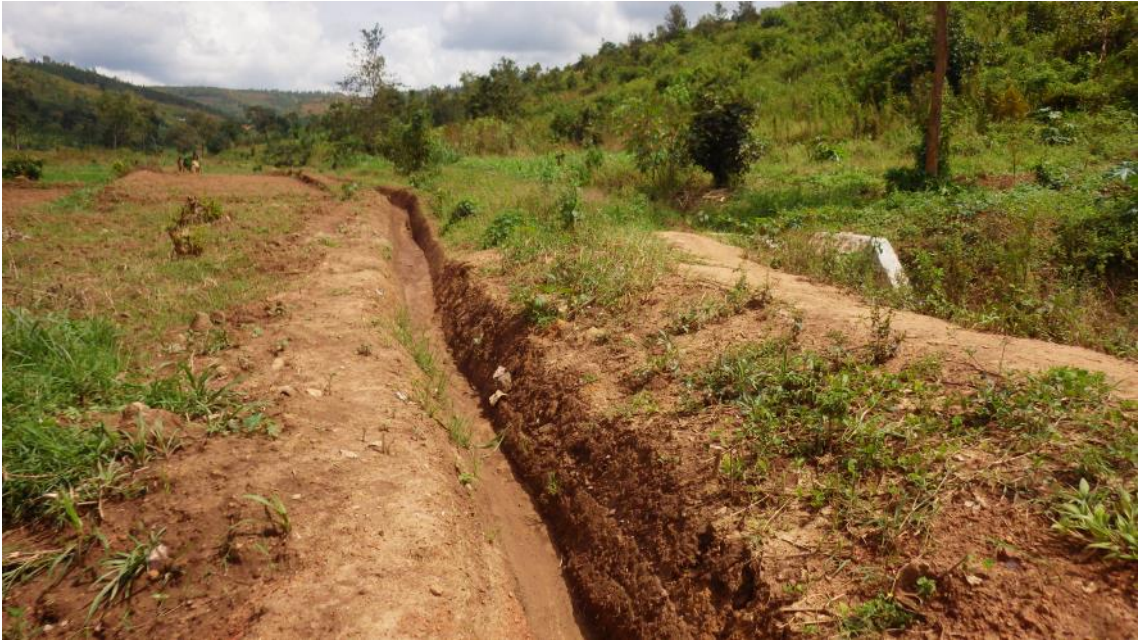
This is the diversion weir developed by QWMDP in 2015.

The right canal is functioning; the water is flowing in the canal.

On the other hand, the left side of the canal is not functioning well. Due to the sedimentation and bad leveling, the water doesn't reach the downstream areas of the canal.

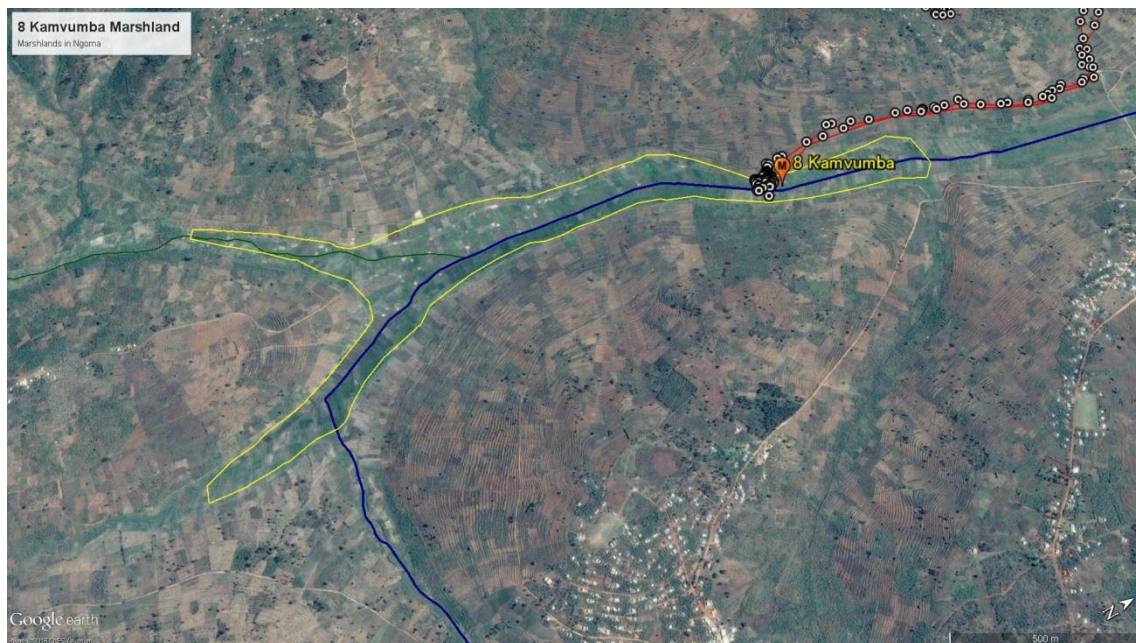
We went to the Kamvumba Marshland on 27th April, 2016 with Ms. Angelique who is the RAB staff and the president of the Cooperative. This marshland is located in the Remera Sector. It is a small Marshland and has not been developed, but the farmers are cultivating rice and vegetables.

The problem is the bad distribution of water due to the bad irrigation network.

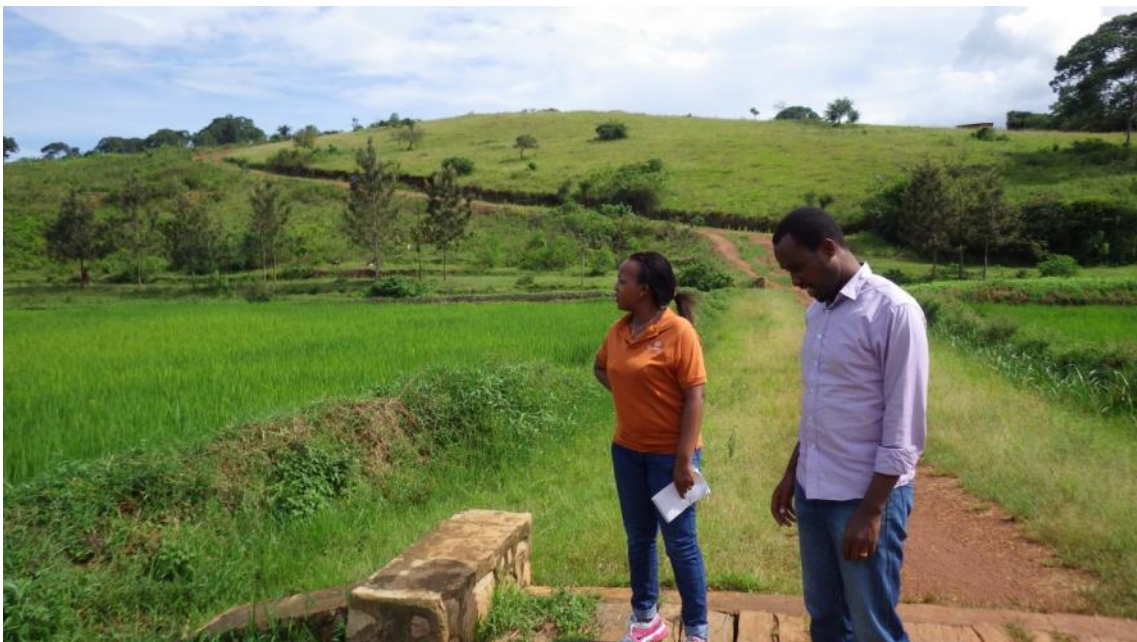
The maintenance of the drainage is not good. The IWUO of this Marshland have to clean up the weed in the drainage.

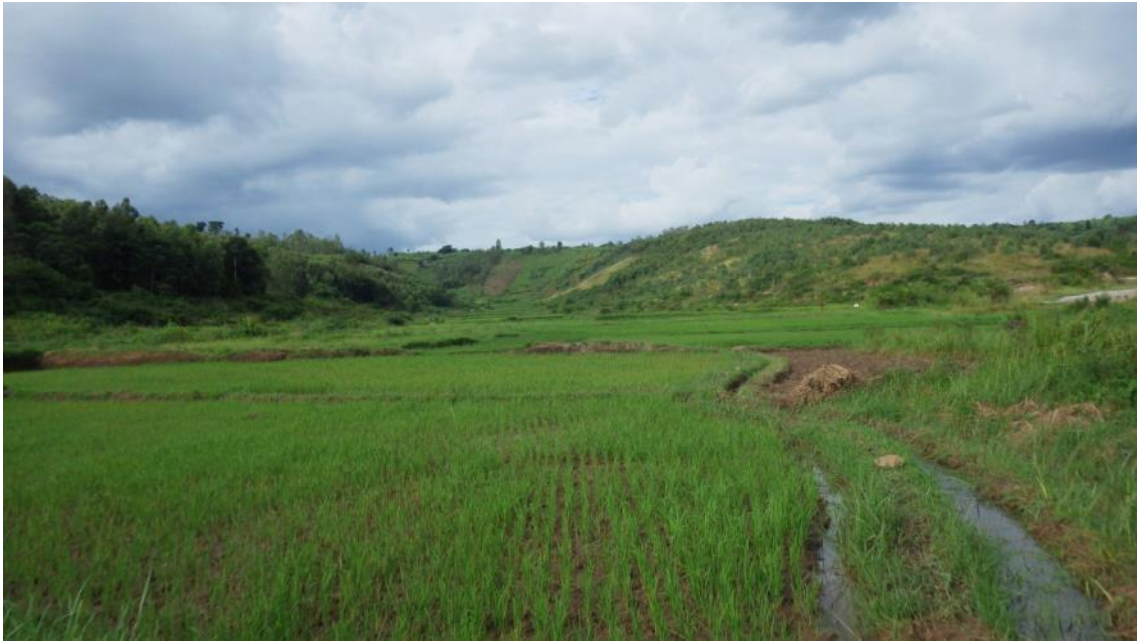
They are annoyed by sandy soil. It is not suitable for rice.

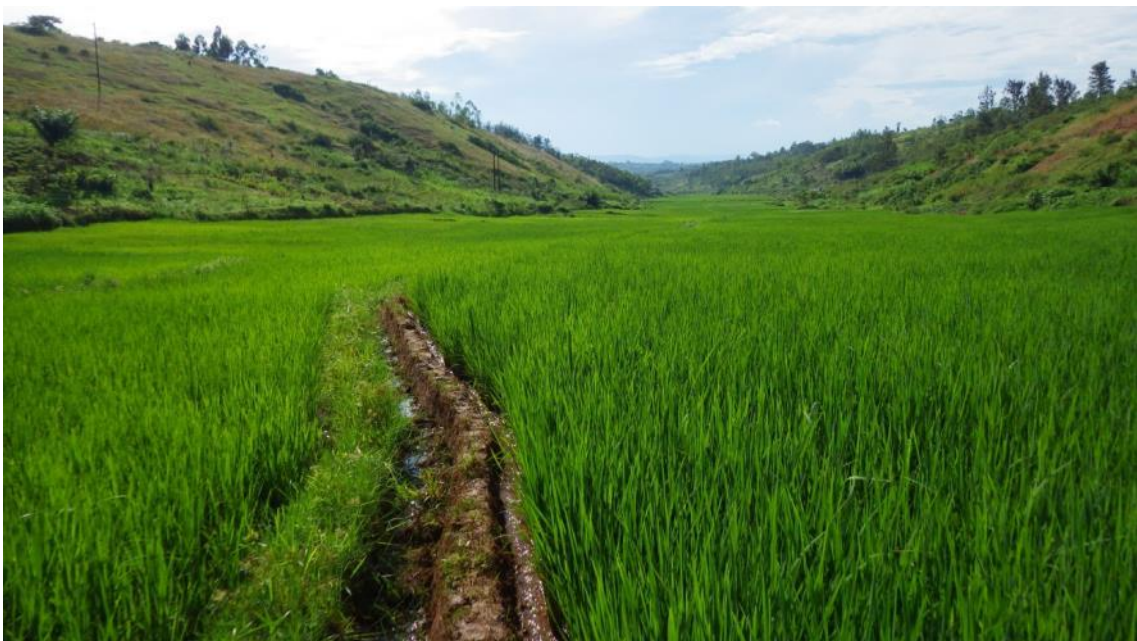
The problem is the water distribution.

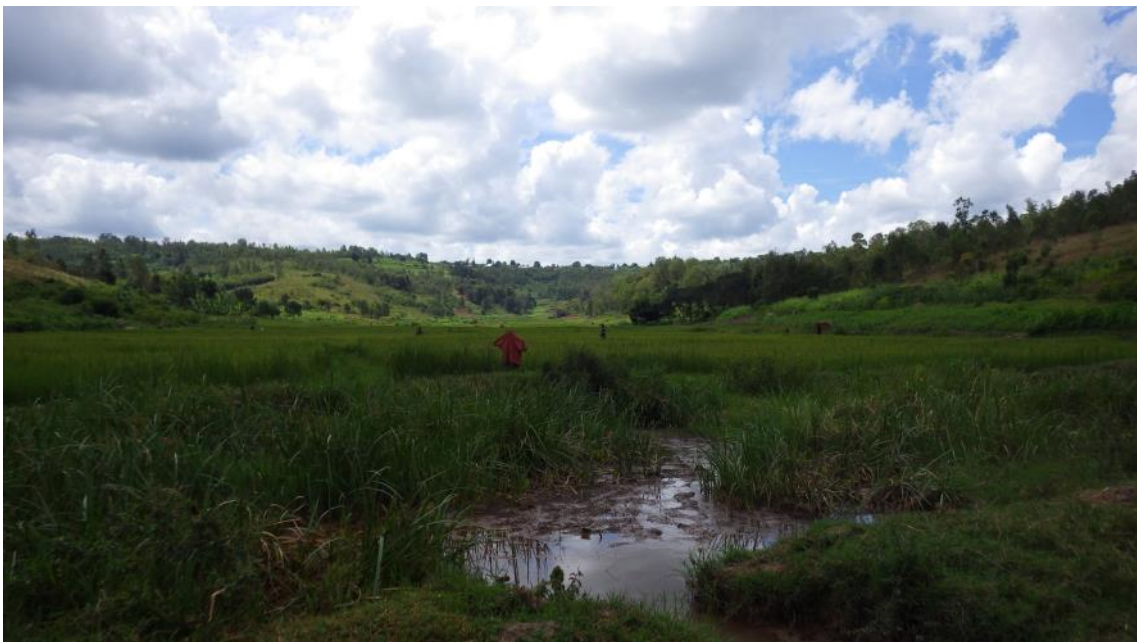
The pond is not effective, it is recommended to make a good pond instead of this.

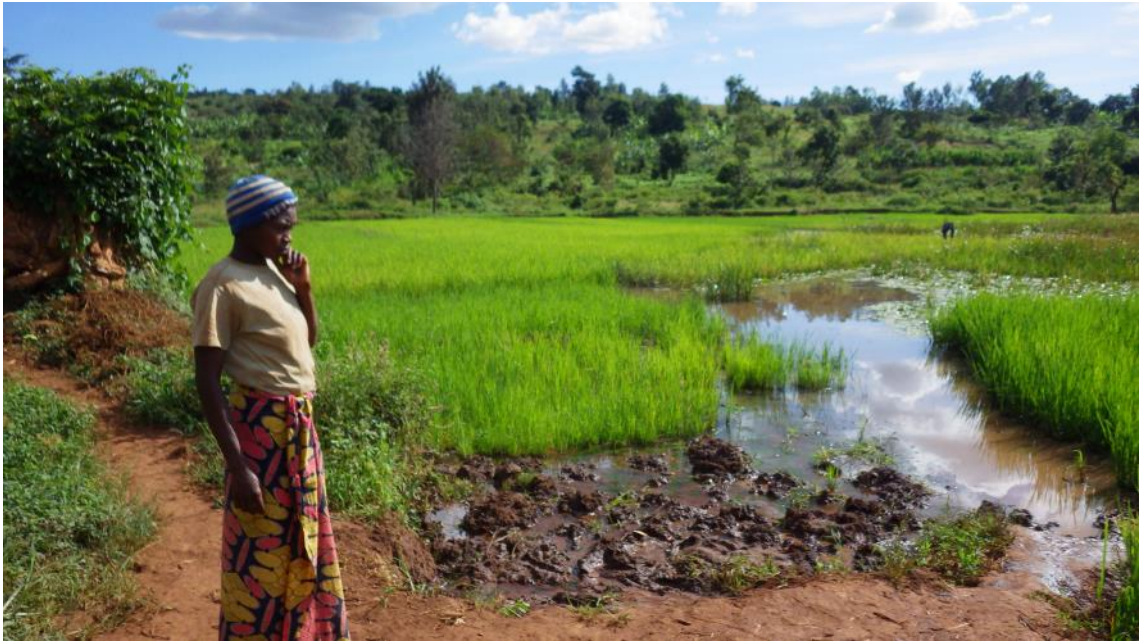
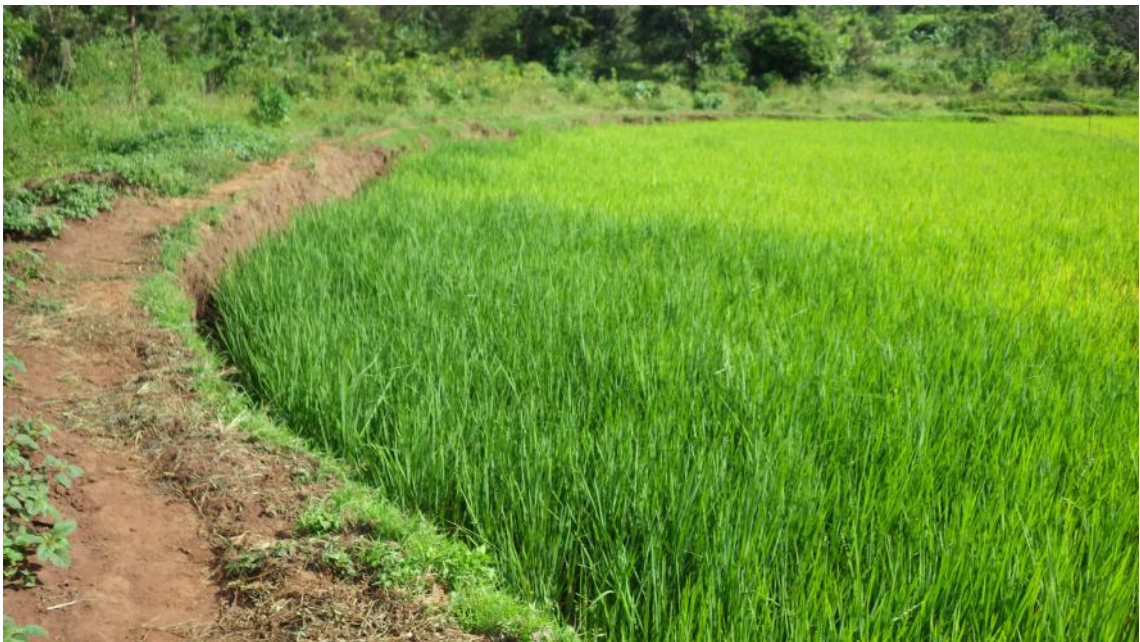
The paddy field is inside the lake.

They dug the ridge of the lake shore and made the paddy field.
